PHYTOTOXICOLOGY ASSESSMENT
SURVEY
IN THE VICINITY OF
LAMBTON COUNTY LANDFILL
SITE, SARNIA, 1991

ARB No. 166-91-PHYTO

ARB No. 166-91-Phyto
Author George N. Vasiloff

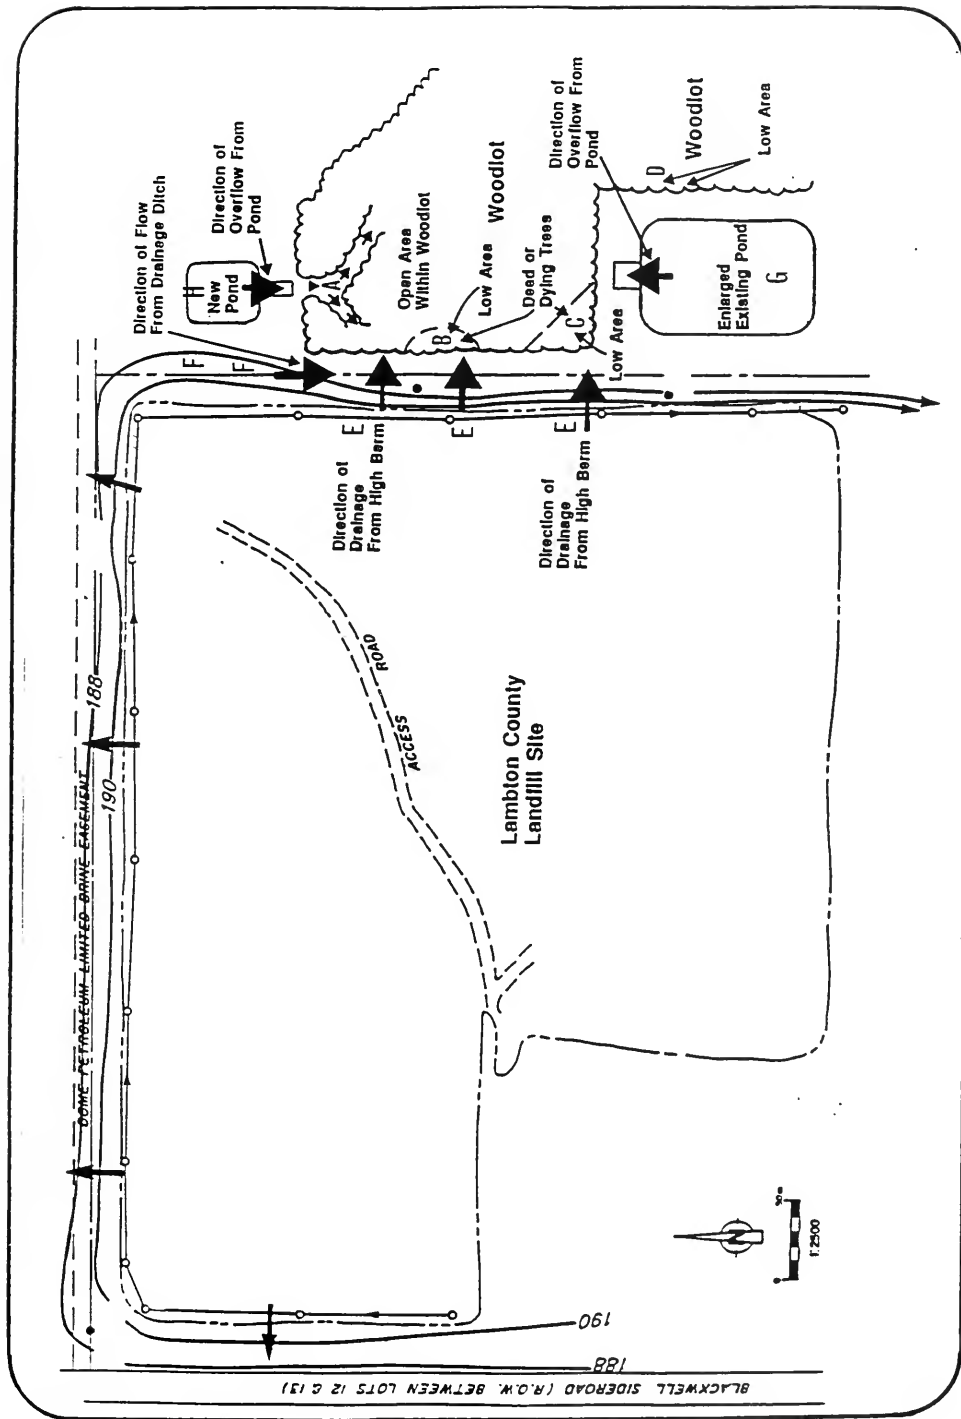
FIGURE: 1 Location of Woodlot in Relation to Lambton County Landfill Site

Phytotoxicology investigators A. Kuja and G. Vasiloff visited the Lambton County landfill site on September 10, 1991. Figure 1 shows the location of the small woodlot in relation to the landfill site and associated structures. A number of dead and dying silver maple trees were examined at three distinct locations (Sites A, B and C) within the woodlot located immediately east of the landfill site.

The eastern perimeter of the landfill site consists of a massive berm that angles down severely to near the edge of the woodlot. Locations along the berm are identified as Site E in the figure 1. Several years ago, a keyed berm was installed along this stretch of this structure. This procedure involves the excavation of clay from a trench along the berm down to the compacted clay base. The excavated clay is compacted and placed back within the trench. A leachate collection pipe is installed in the middle of the compacted clay in the trench. From an engineering standpoint, a keyed berm constructed in this manner is considered impervious to the penetration of leachate from the landfill site. Sarnia Ministry staff have indicated that the keying was undertaken to prevent leachate from leaking from the landfill site. Although the decline of the trees is not a direct result of the construction, grade changes associated with the construction likely caused additional surface waters to collect within the low areas of the woodlot.

Farther north along the berm (Site F, Figure 1), the base of the berm was graded in such a way that surface water is channelled and flows in a southerly direction and ultimately drains into the western edge of the woodlot.

Phytotoxicology investigators examined dead and dying silver maple trees in a small woodlot adjacent to the Lambton County landfill site. Physical evidence indicated that grade changes of the berm along the eastern perimeter of the site and the discharge from two settling ponds had resulted in the flooding of low areas in the woodlot. Although silver maple are able to withstand intermittent flooding, it appears that the affected trees have been subjected to flooded soils over a protracted period of time. The wet conditions have already killed some of the trees. Other trees that are under considerable stress will eventually succumb if the flooding persists. No evidence of foliar injury related to toxic leachate was observed on vegetation located between the landfill site and the woodlot.

The construction of an adequate drainage to direct storm water around the woodlot and other appropriate locations should prevent further flooding and loss of trees.

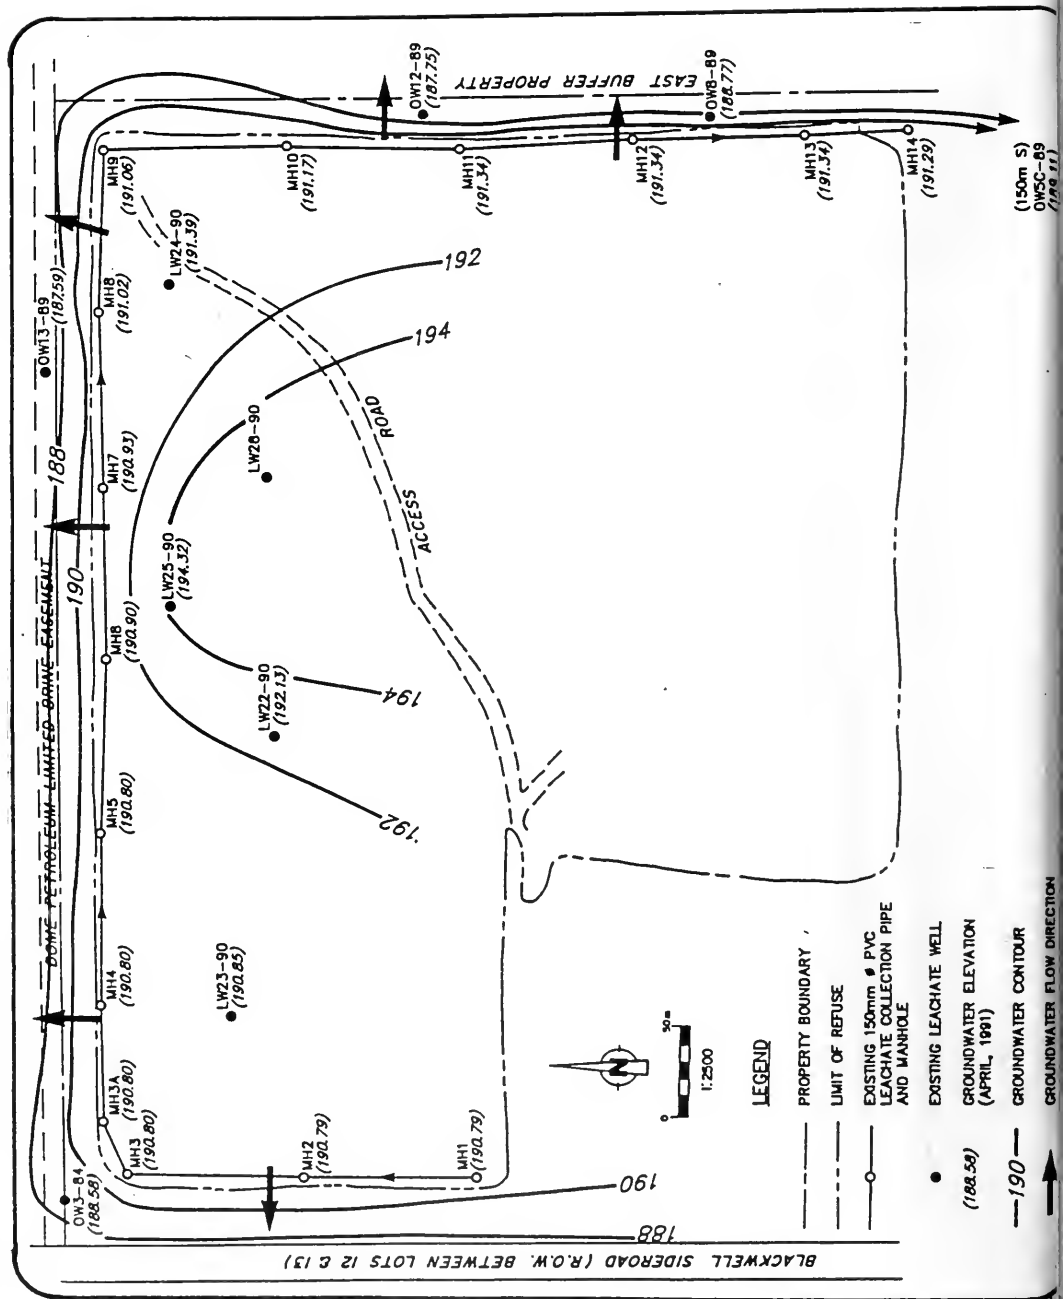
FIGURE: 2 Lambton County Landfill Site Showing Groundwater Potentiometric Surface

Examination of the berm and other landfill site-related structures adjacent to the woodlot indicated that grade changes had caused surface drainage waters from a number of locations to collect at the edge of the woodlot. Figure 2 is a view of the landfill site showing the groundwater potentiometric surface. This figure shows elevations of the perimeter areas of the landfill site and drainage flow directions.
